Fine grained sediment clean-up in a modern urban environment

A thesis

Master of Science in Hazard and Disaster Management

University of Canterbury

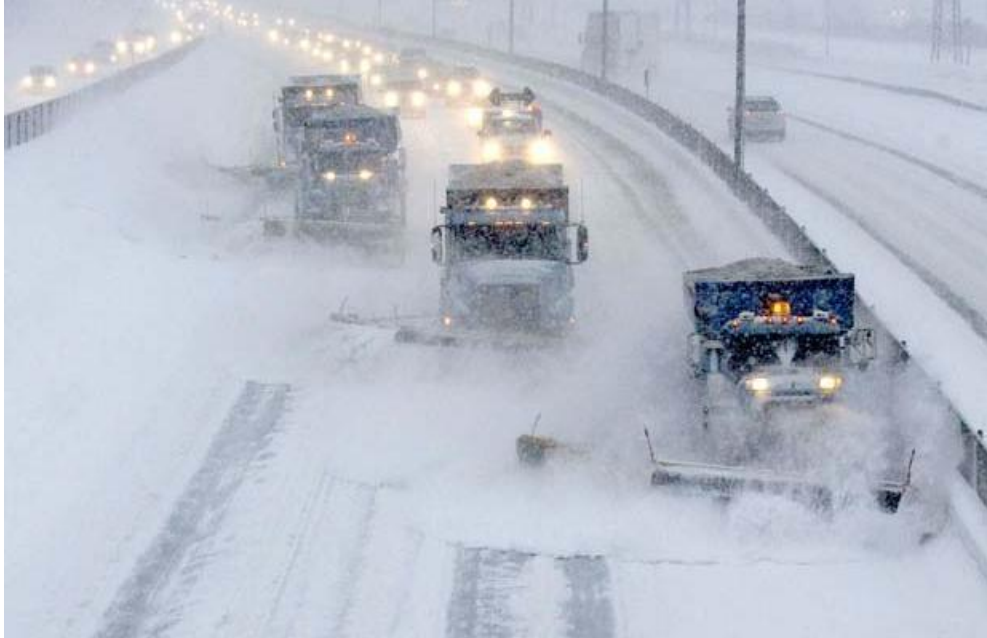
FIGURE 4: SNOW REMOVAL ALONG A HIGHWAY IN MONTREAL (CANADA) BY CONTRACTORS PHOTO CREDIT: ALLEN MCINNIS, MONTREAL GAZETTE

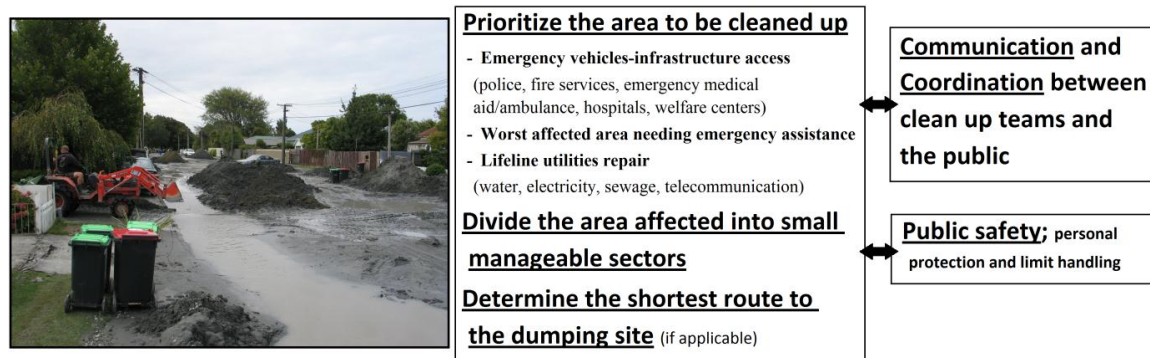
FIGURE 8: GENERAL STRATEGY FOR CHRISTCHURCH LIQUEFACTION CLEAN-UP. PHOTO: PILES OF LIQUEFACTION EJECTA CLEANED FROM RESIDENTIAL PROPERTIES AND ROADS, READY FOR REMOVAL BY HEAVY EARTH MOVING MACHINERY AT BRACKEN STREET IN THE SUBURB OF AVONSIDE FOLLOWING THE CHRISTCHURCH 1 EVENT. (PHOTO CREDIT: JARG PETTINGA)

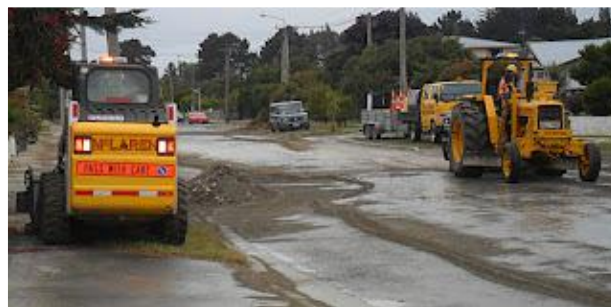
FIGURE 10: QUAKE DAMAGED SINCLAIR ST, POST 23.12.11. PHOTO CREDIT: MARK JS ESSLEMONT, WOZA WANDERER BLOG, 2011

- 2) Contractor undertakes an initial ejecta removal from the street and pathways to facilitate transport - typically using heavy earth moving machinery (Figure 10).

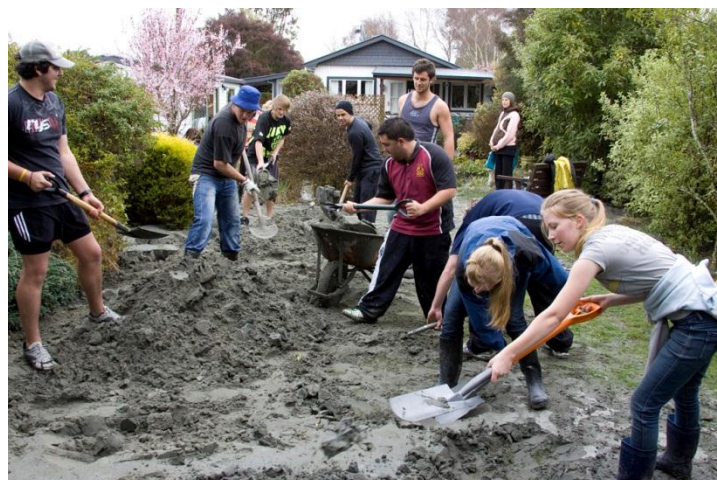
FIGURE 11: STUDENT VOLUNTEER ARMY HELPING WITH THE EARTHQUAKE CLEAN-UP. PHOTO CREDIT: UNIVERSITY OF CANTERBURY EVE WELCH

- 3) Contractors, volunteers and property owners/residents remove ejecta by hand (i.e. shovel and wheelbarrow) from difficult to reach areas that machinery cannot reach, including private properties, areas around vehicles, gardens, driveways and schools (Figure 11). Material is accumulated in the street away from the curb (for easy pick up by diggers or loaders) and away from drains (to avoid sediment ingestion into waste water networks).

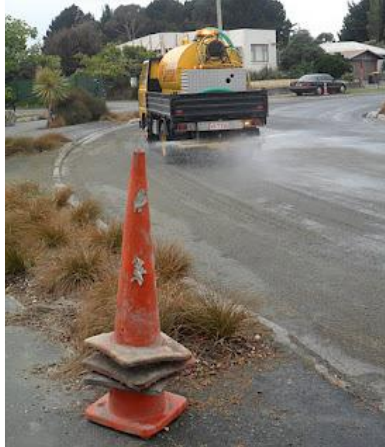
FIGURE 12: CONTRACTORS SPRINKLING THE QUAKE DAMAGED SINCLAIR ST. AND RAWSON ST. (PHOTO CREDIT: MARK JS ESSELMONT, WOZA WANDERER BLOG, 2011)

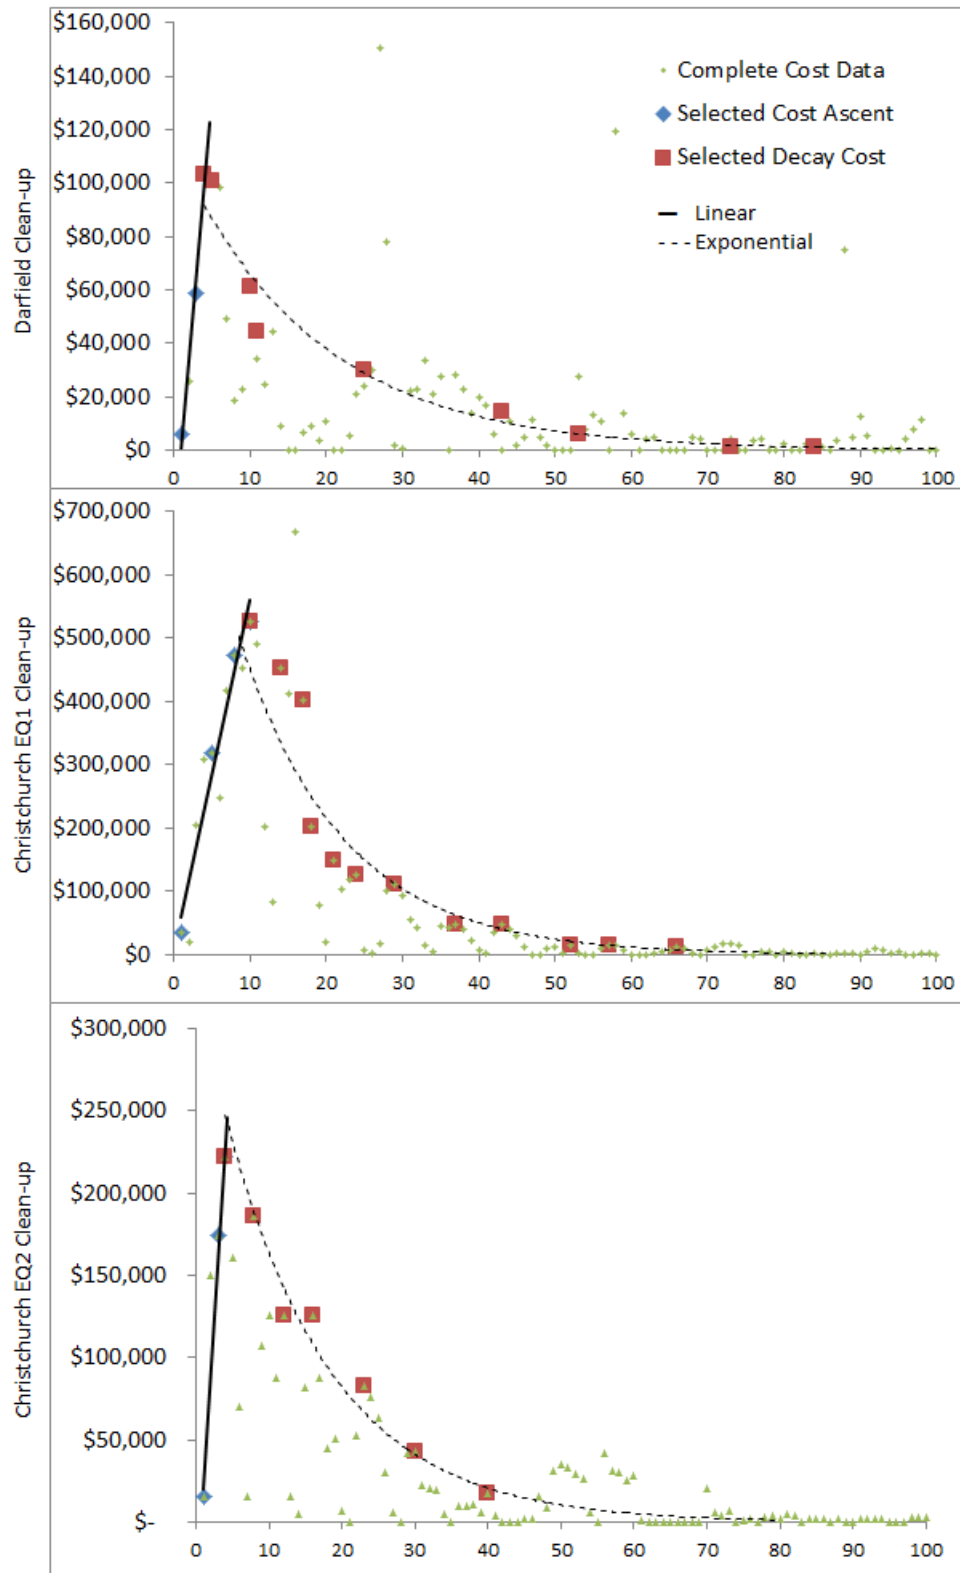
FIGURE 23: GRAPHS OF THE BEST FIT CURVES FOR THE ASCENT AND DECAY OF THE COSTS EVOLUTION THROUGH TIME FOR THE 3 MAJOR EVENTS FOR THE SELECTED VALUES

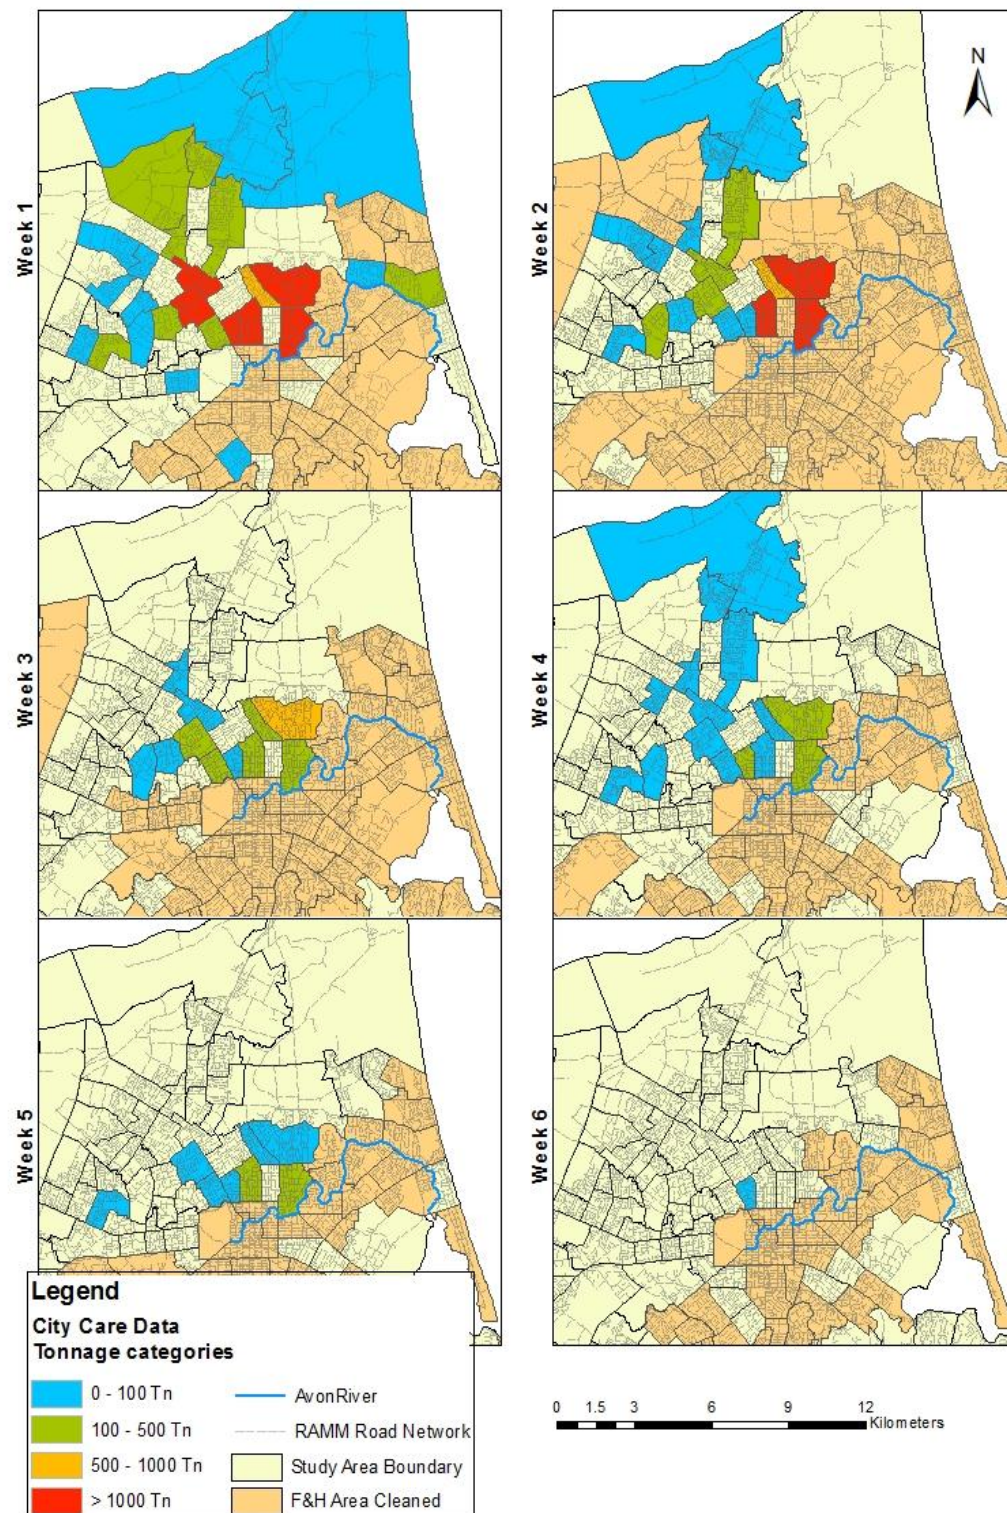
FIGURE 33: CITY CARE WEEKLY CLEAN-UP ACTIVITY OVER TIME BASED ON VOLUME CLEANED OVER THE FULTON AND HOGAN CLEANED AREAS

The geospatial distribution of the *City Care* ejecta clean-up was analysed on a weekly basis to complete the Fulton and Hogan spatial and temporal clean-up distribution analysis. Volume categories were created to illustrate the volumes cleaned from each suburb. Figure 33 presents the weekly maps of the volume cleaned by *City Care* following the Christchurch 1 earthquake as well as the area cleaned by *Fulton & Hogan*. From this it is possible to observe that large volumes of liquefaction ejecta were cleaned from the suburbs during the first 2 weeks. Week 3 clean-up was moderate with still volume cleaned within the 500 – 1,000 t category. Week 4 and 5 present a low level of intensity but is still located within highly affected area around the Avon River. This data is similar to the weekly cost repartition from the RAMM data spatial analysis where most of the efforts were concentrated within the first three weeks.

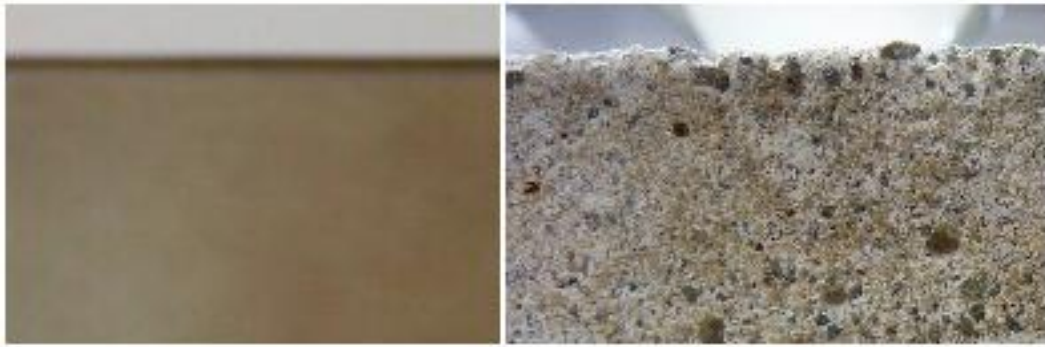
FIGURE 47: REPRESENTATION OF THE SMOOTH AND ROUGH SURFACE USED IN THE EXPERIMENT. SCALE: THE LENGTH OF EACH PHOTO IS ABOUT 6CM

The angle of repose was tested for dry samples on flat and porous base (Figure 47). Each sample would be tested 5 times and the following measurements would be taken for each test:

Base length is measured using a 150 mm long caliper with a precision of 0.01 mm. The vertical height was measured in 2 different ways. The first was measured from the base of the funnel to the base of the platform and should be the same for all measurement; 3.81 cm (1.5 inch) or and the second was from top of the pile to the base of the platform.
